HA=1556

Aberdeen Esso Service Station

INVENTORY FORM FOR STATE HISTORIC SITES SURVEY

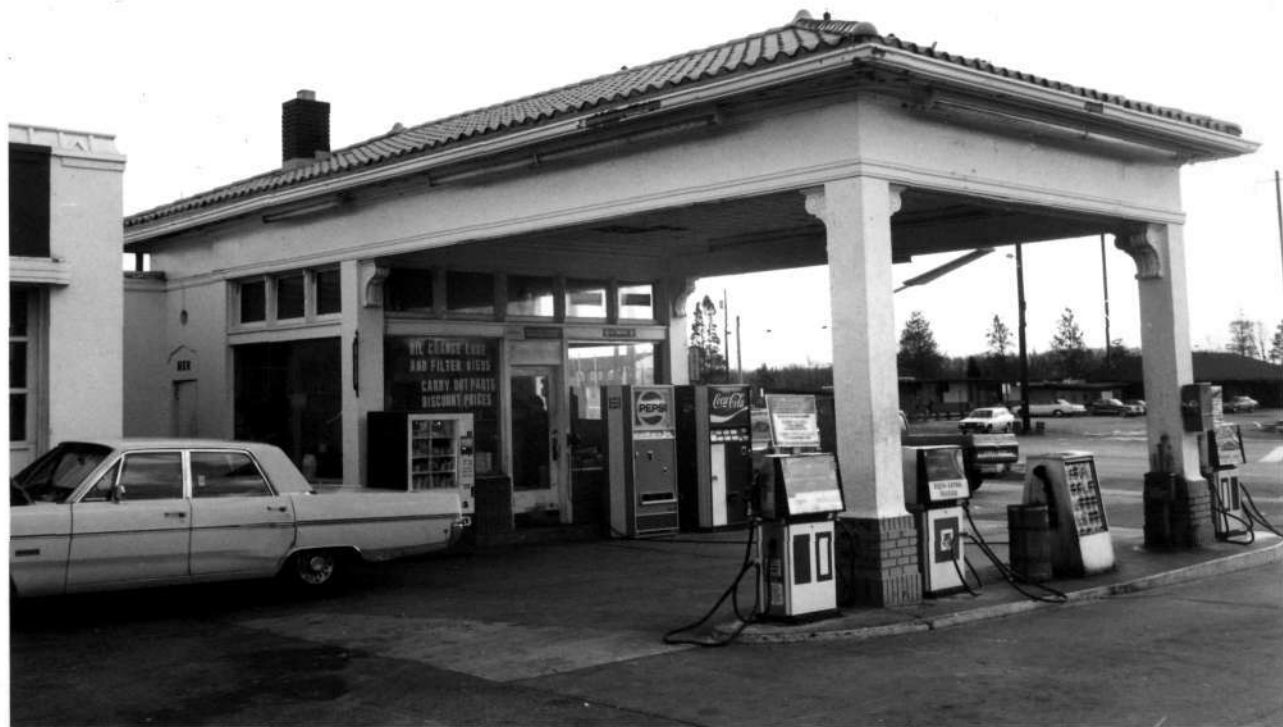
HA-1556

The building, facing west across U.S. 40, is a one-story office with a covered driveway and gas pump island. A hipped tile roof covers the entire structure. The exterior is stucco.

general view from north

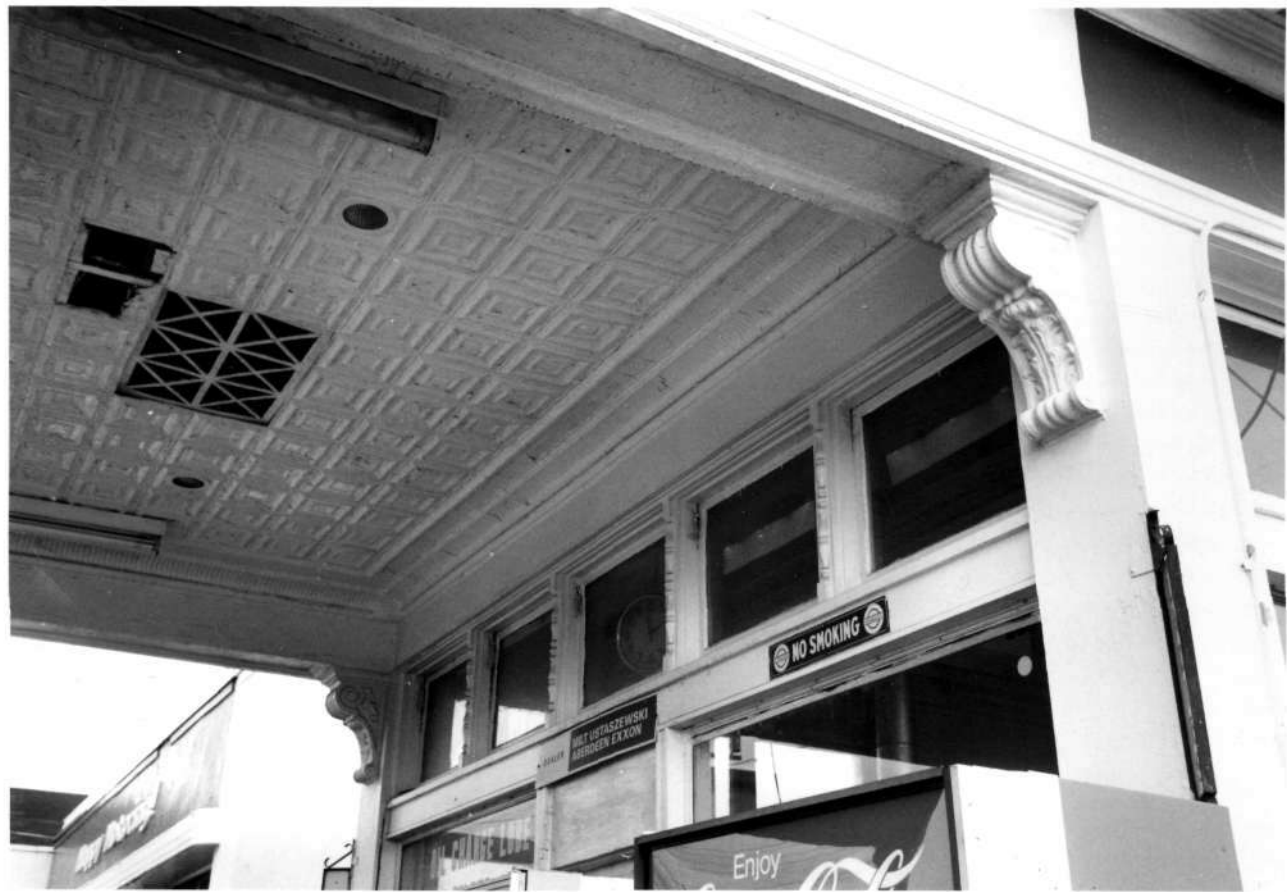
HA 1556

The office section has plate glass windows facing the paved service area on the north, west, and south. A series of small square panes above a transom bar tops each window. The restrooms are behind the office area and are reached by separate outside doors on the north and south elevations. The doorways are placed within blind molded arches in the stucco. The overhanging roof of the driveway has foliated scroll corbels. The soffit of the overhang is covered with pressed metal sheets in a square-within-square pattern.

detail of canopy

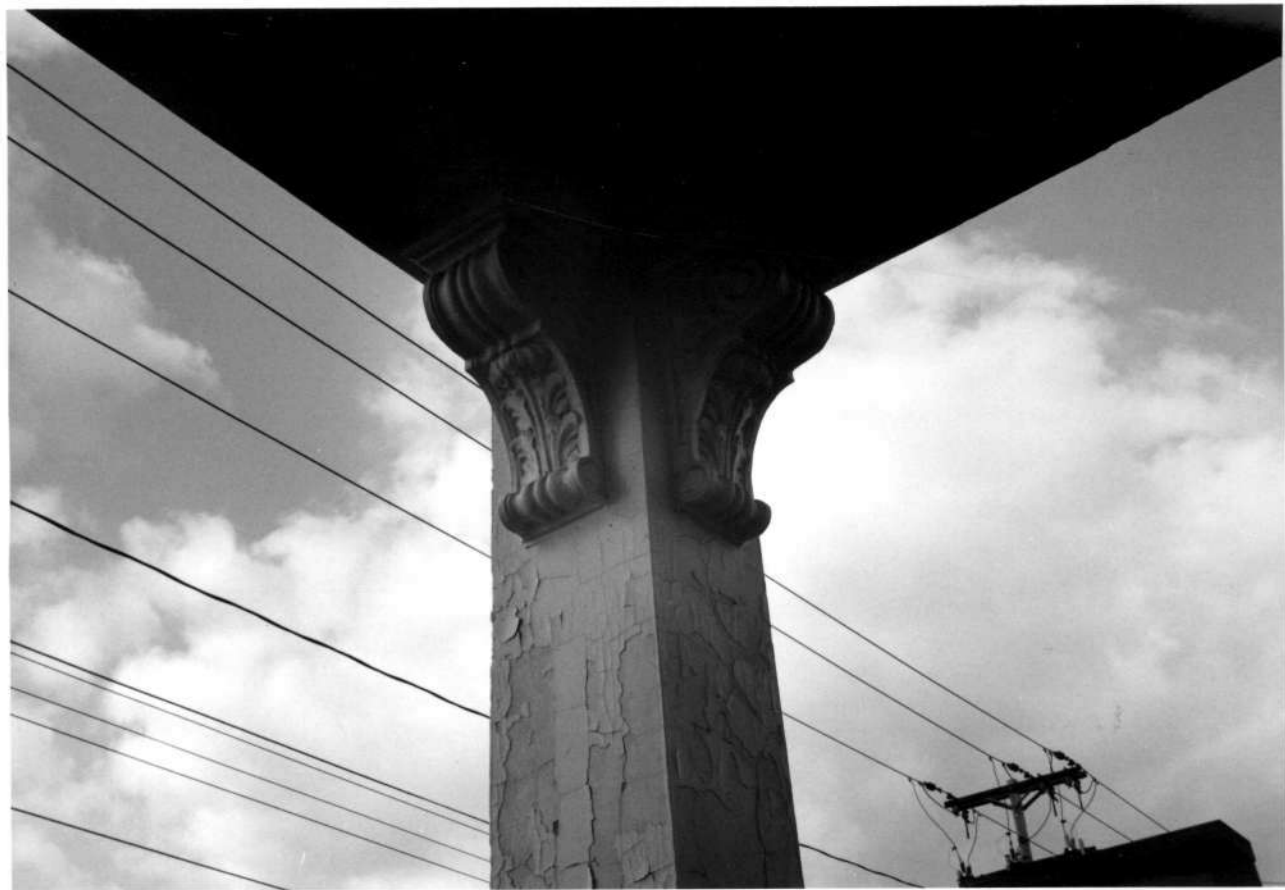
HA-1556

detail of canopy console
